KIWANIS RAVINE

SPU Aquatic Habitat Grant Phase II Monitoring & Maintenance Report - Year 3

January 5, 2010

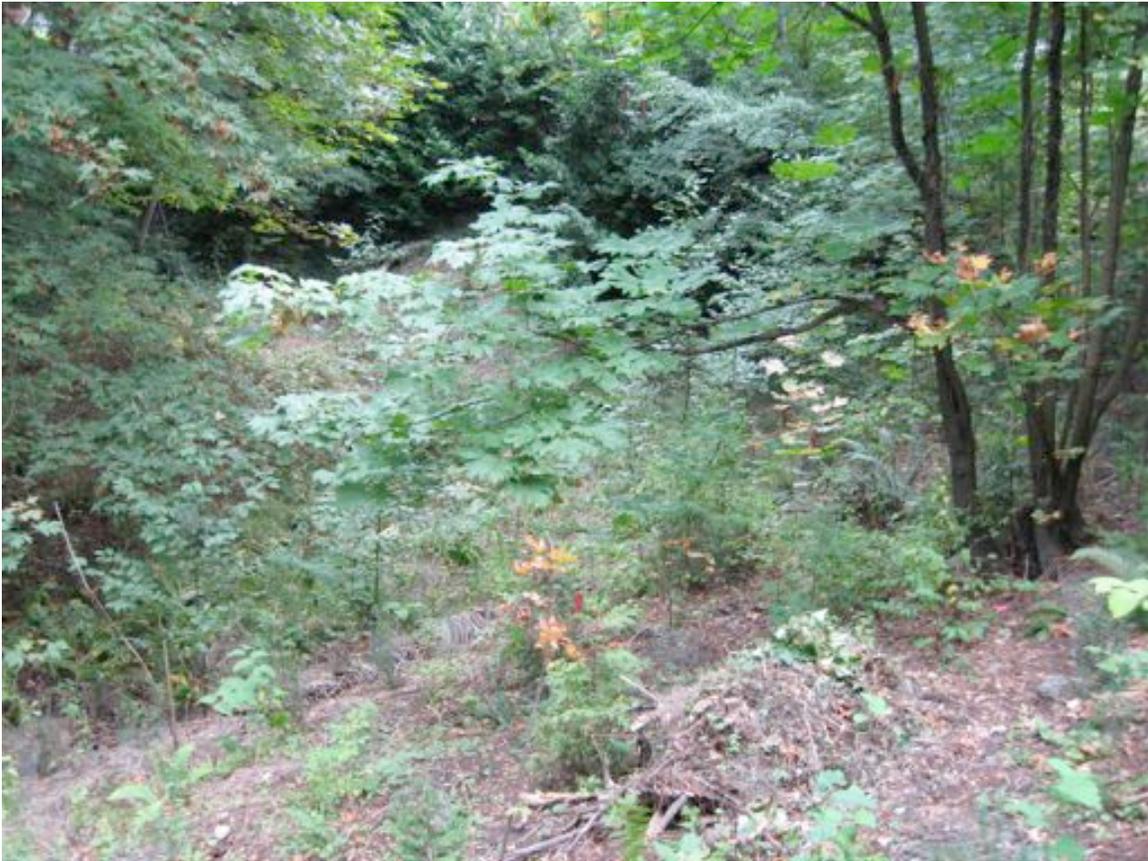
Cover image: East fork site, Kiwanis Ravine AHG Phase II. Looking downhill from the top of the slope.

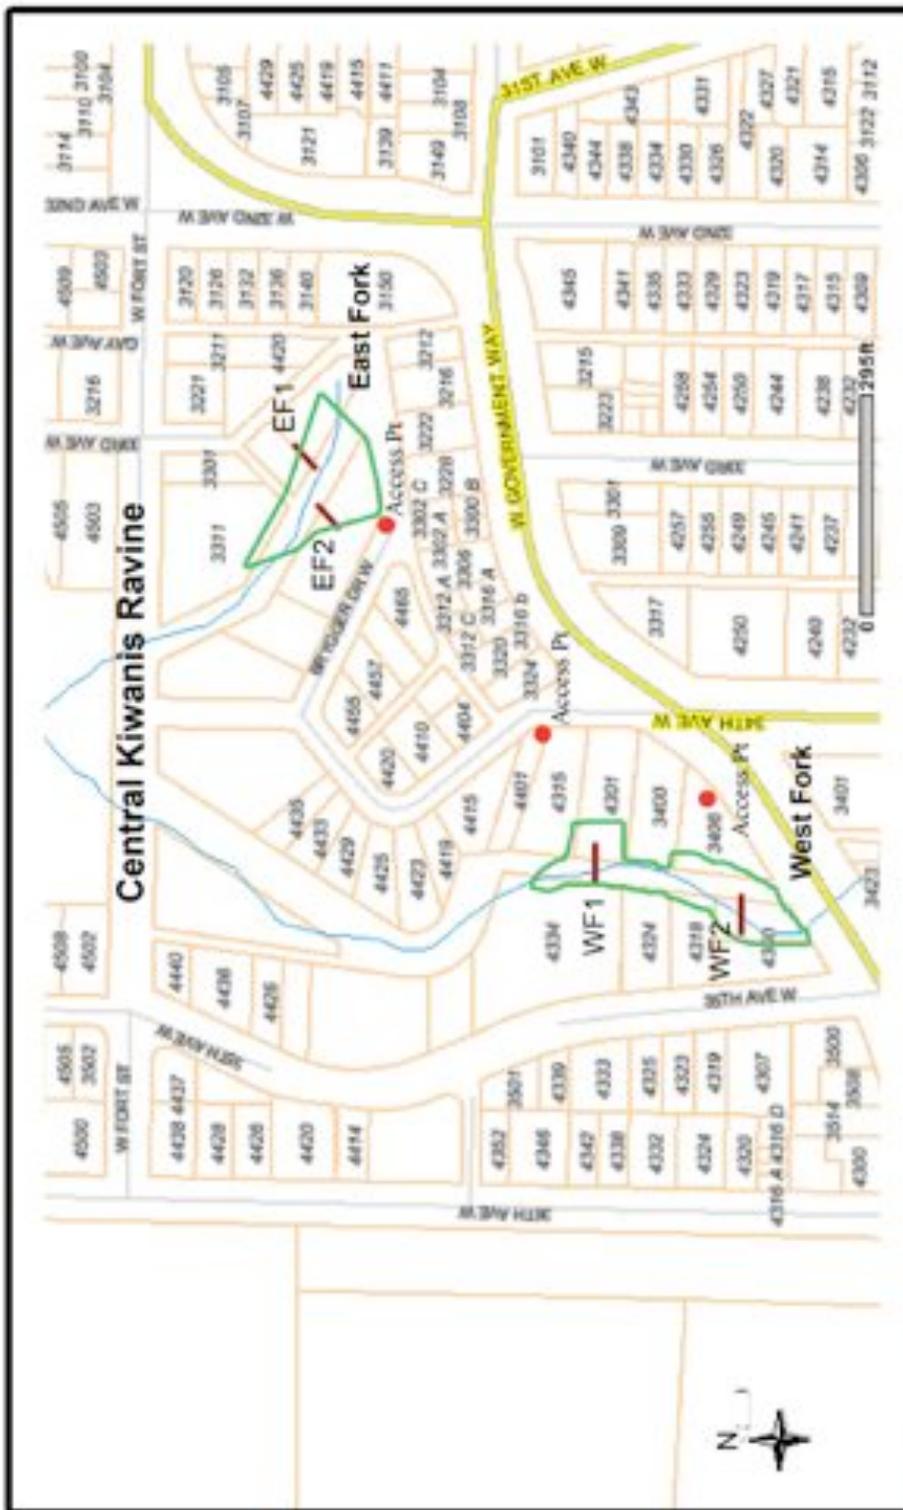
Kiwanis Ravine Restoration Aquatic Habitat Grant 2007

Four monitoring transects (two in each fork of the ravine) were set up during baseline monitoring, conducted on September 10, 2007, prior to the initial restoration. Each transect is fifty feet in length and oriented perpendicular to the stream. Approximate transect locations are described in the Year 1 final report. At each transect the following methods were used to collect data that is consistent and comparable with the previous year's. The same methods will be used to conduct monitoring prior to maintenance work in late summer or early fall of 2010.
